INSTALLERS BEWARE!

Installers beware! Stone Plastic/Polymor Composite (SPC) flooring is simultaneously strong and fragile and not as forgiving as LVT or Laminate during installation.

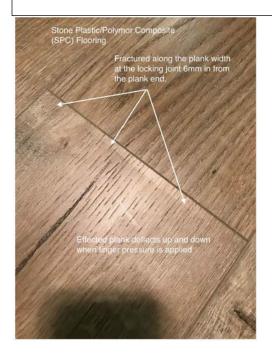
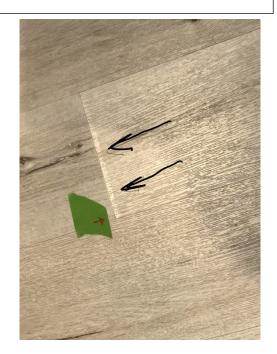
The tell-tale ski jump (in this photo) at the butt end of multiple installed boards indicates broken joints, usually associated with incorrect handling or excessive mallet impact. SPC joints are thin and brittle and if installed without the necessary care and attention such as use of a tapping block to spread the load of mallet impacts, also the correct disengagement method for removal and re-installation of planks, then microfracturing of the end joint can easily occur. Once this happens the issue may be obvious at time of installation or may take months to develop as fractures worsen with use. For this reason, installers switching between LVT or laminate and SPC installation work should take time understand the locking joint, modify installation techniques and always review manufacturer installation guidelines to avoid the problems. www.nfca.ca #flooring #renovations #construction #vinylflooring #spcflooring

Extra care when engaging the locking joint, understanding its weaknesses and how to tap it together will make the difference between a satisfied client and just another claim.
